## **An Investigation of Concrete Deterioration at South Florida Water Management District Structure S65E**

February 2014

Final report

Prepared for US Army Engineer District, Jacksonville  
701 San Marco Blvd  
Jacksonville, FL 32207

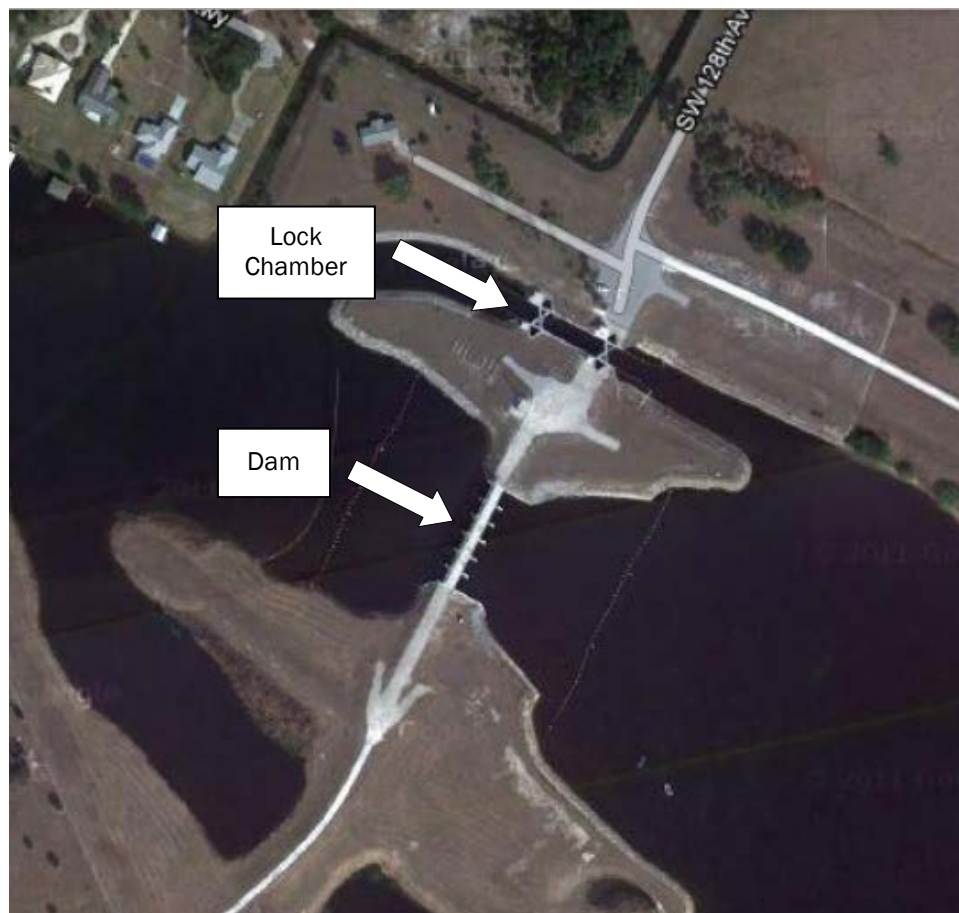
Figure 1. Aerial view of lock and dam structure S65E.

The Concrete and Materials Branch (CMB), Geotechnical and Structures Laboratory (GSL), US Army Engineer Research and Development Center (ERDC) was requested to perform an analysis of concrete deterioration occurring at inland navigation structure S65E, owned and operated by the South Florida Water Management District (SFWMD). The request for ERDC assistance was made in conjunction with work being conducted by the US Army Engineer District, Jacksonville, in collaboration with the SFWMD. An aerial view of structure S65E is provided in Figure 1.

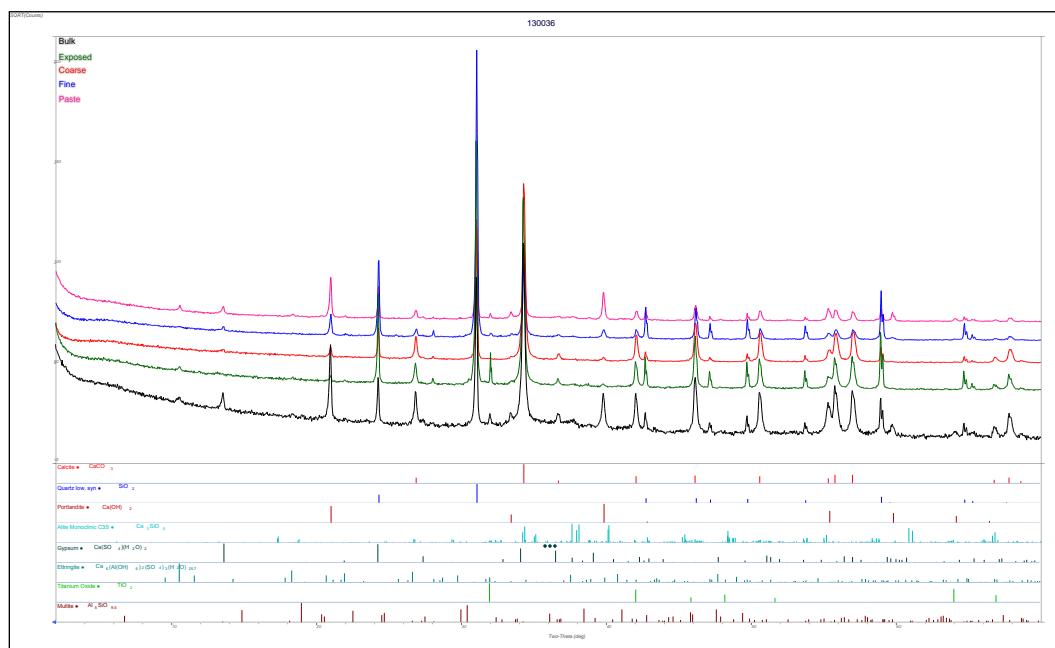
XRD measurements were performed to determine the mineralogy of various phases present in the concrete and the differences between non-deteriorated bulk concrete and deteriorated surface concrete. Figure 15 shows typical XRD patterns of various constituents and regions investigated: coarse aggregate, fine aggregate, hydrated cement paste, bulk-deteriorated concrete, and deteriorated exposed concrete. Phases qualitatively identified to be present are shown at the bottom of Figure 15.

Figure 15. XRD patterns for non-deteriorated bulk concrete, exposed deteriorated concrete, coarse aggregates, fine aggregates, and hydrated cement paste with phases qualitatively identified as shown at the bottom of the plot and corresponding to the peak location in XRD pattern.

As anticipated, the coarse aggregate was primarily composed of Pleistocene limestone, containing the calcite polymorph of  $\text{CaCO}_3$ . The fine aggregate was primarily siliceous, containing the quartz polymorph of  $\text{SiO}_2$ . The paste has additional phases resulting from cement hydration, including ettringite and portlandite, along with unreacted gypsum and alite ( $\text{C}_3\text{S}$ ) contributed by portland cement.

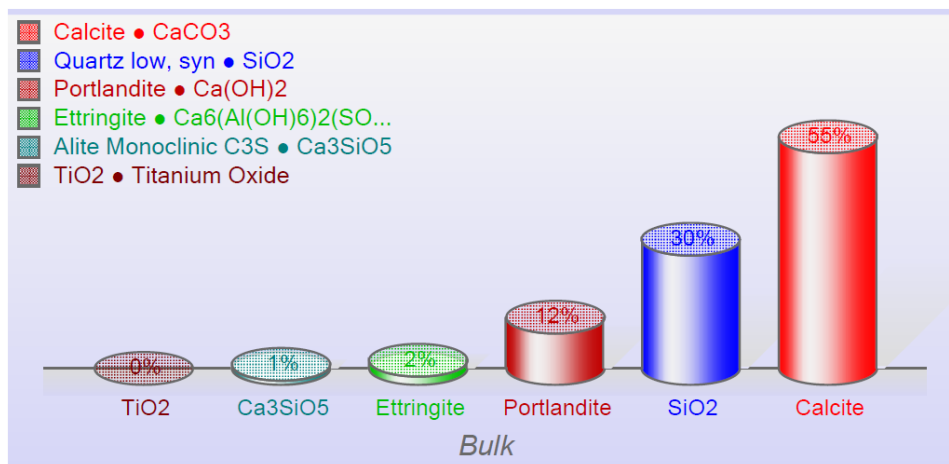
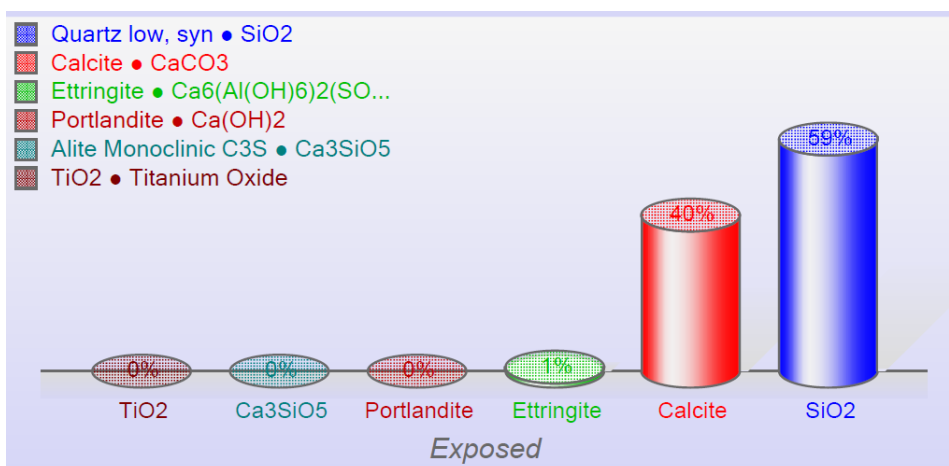
The most useful comparisons can be made between the bulk non-deteriorated concrete and the surface deteriorated concrete. Figure 16 presents the results of quantitative whole pattern fitting of samples from bulk non-deteriorated concrete and surface deteriorated concrete.

Figure 16. Results from quantitative XRD whole pattern fitting from bulk concrete and surface concrete from exposed areas that exhibited deterioration.

a. Quantitative analysis results from bulk non-deteriorated concrete.

b. Quantitative analysis results from surface deteriorated concrete.

In the case of the bulk non-deteriorated concrete, calcite, associated with coarse aggregates, and quartz ( $\text{SiO}_2$ ), associated with fine aggregates, dominated the composition, followed by cement hydration products portlandite ( $\text{Ca}(\text{OH})_2$ ) and ettringite ( $\sim\text{Ca}_6(\text{Al}(\text{OH})_2)_2(\text{SO}_4)_3(\text{H}_2\text{O})_{25}$ ), along with residual unhydrated cement (Alite/ $\text{C}_3\text{S}$ ). In the surface deteriorated concrete, significantly more quartz was present from undamaged fine aggregates, and less calcite was present from the deterioration of Pleistocene coarse aggregates. A reduction in soluble hydrates including portlandite and ettringite occurred. The loss of portlandite and ettringite at the surface is typical for leaching of these highly soluble phases in high-moisture environments. The lack of ettringite or other phases typically present in concrete damaged by sulfate attack such as gypsum supports our hypothesis that sulfate attack is likely not a concern, as  $\text{SO}_4^{2-}$  concentrations are low in the local water at S65E. The reduction in calcite and increase in quartz composition at the surface also supports the hypothesis that biodeterioration may be leading to distress by consumption of limestone coarse aggregates and the paste. However, this finding is highly related to the location of sampling on the concrete core.

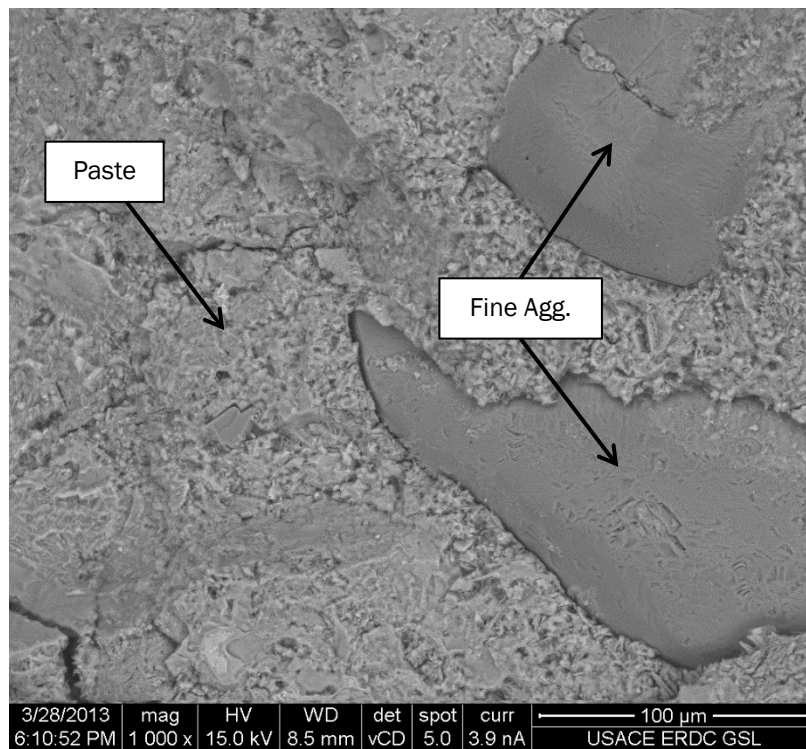
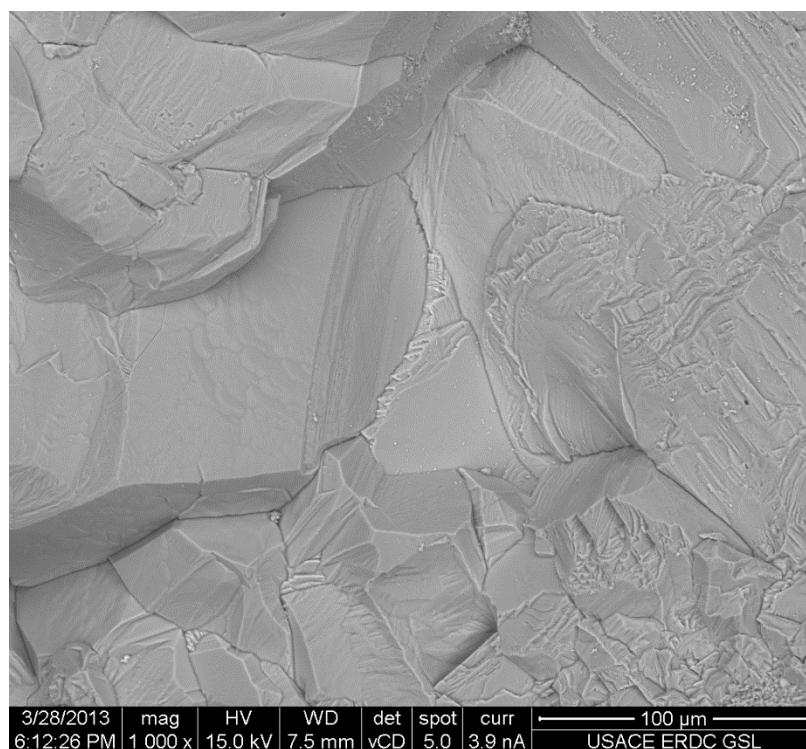
Further examination of microcores extracted from the surface and split longitudinally was used to investigate damage from the surface in. Figure 19 shows examples of deterioration observed on the fracture surface and the transition between the surface deterioration and the non-deteriorated bulk concrete and unaffected aggregates. The inner bulk concrete appeared typical with no detectable other modes of deterioration (see Figure 20).

Figure 20. SEM micrographs of inner bulk non-deteriorated concrete showing typical distribution in paste, fine aggregates, and the Pleistocene limestone coarse aggregate.

a. Fracture surface of bulk concrete showing paste and fine aggregate.

b. Fracture surface of non-deteriorated limestone coarse aggregate.

Results of the SEM investigations confirmed that the deterioration observed in concrete from the lock chamber and dam at S65E is largely concentrated on the surface. Deterioration observed at the surface appeared to be correlated with biological activity and active dissolution of soluble components present in the concrete, as indicated by geochemical water-rock reaction simulations. Dissolution of the paste and limestone coarse aggregates was observed, while the siliceous fine aggregates appeared to be relatively unaffected. Deterioration was correlated with the depth of discoloration observed by petrographic analysis and reported in Section 3.2. The inner bulk concrete did not appear to have any type of detectable deterioration (e.g., sulfate attack or biodeterioration of the paste, coarse aggregate, and fine aggregate).

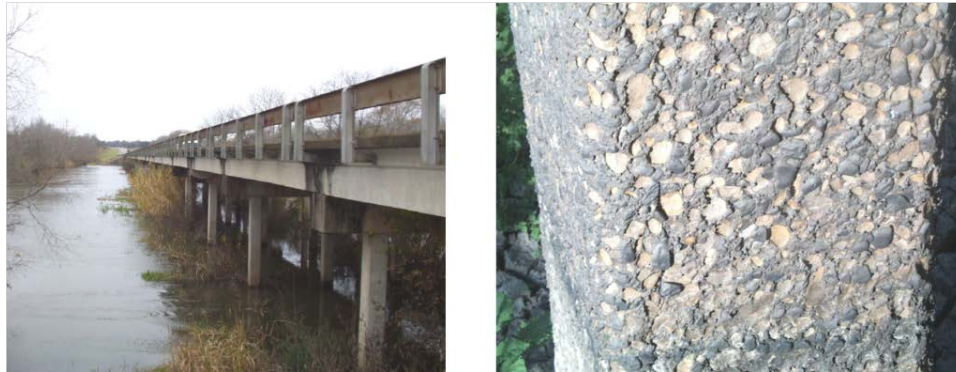
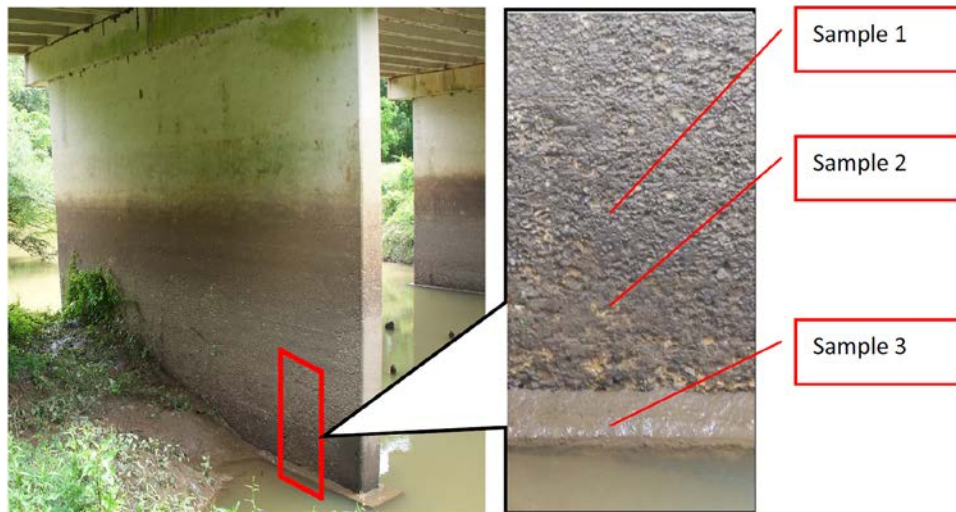
Biodeterioration can explain local deterioration at the surface by acidification and direct or chemical consumption of mineral phases present in concrete (e.g.,  $\text{CaCO}_3$ ). Similar modes of deterioration have recently been reported (see Figure 21). However, water-rock reaction simulations have also evidenced the potential for active dissolution of soluble components in the concrete (e.g., calcite and dolomite) based on the typical local water quality at S65E.

Figure 21. Similar microbial-induced biodeterioration observed in Texas bridge structures exposed to environments similar to those at structure S65E (from Trejo 2008).

a. Example biodeterioration of concrete surface in Texas bridge structure.

b. Sampling locations for study of surface biodeterioration in Texas bridge structure.

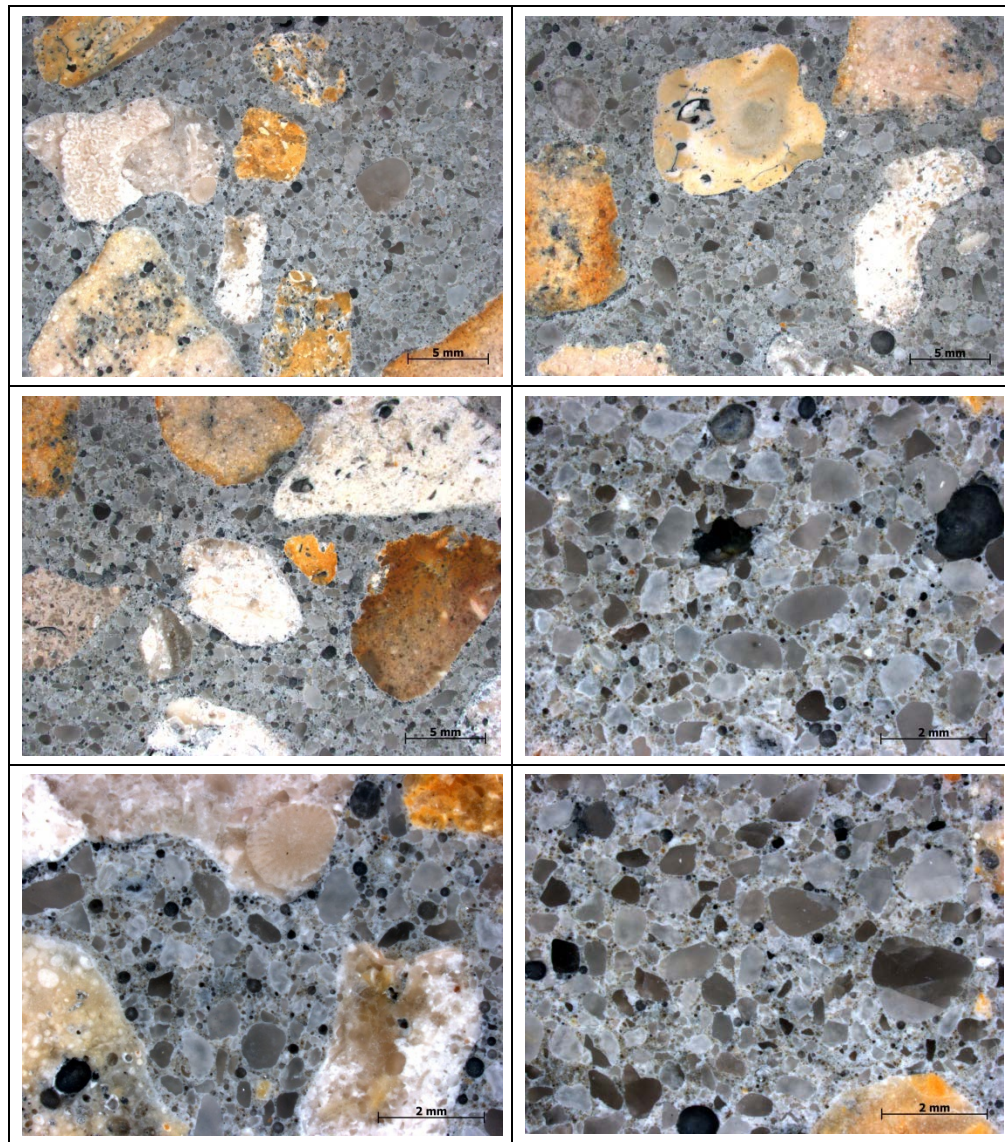
Figure A1. Supplemental photomicrographs of bulk non-deteriorated concrete.

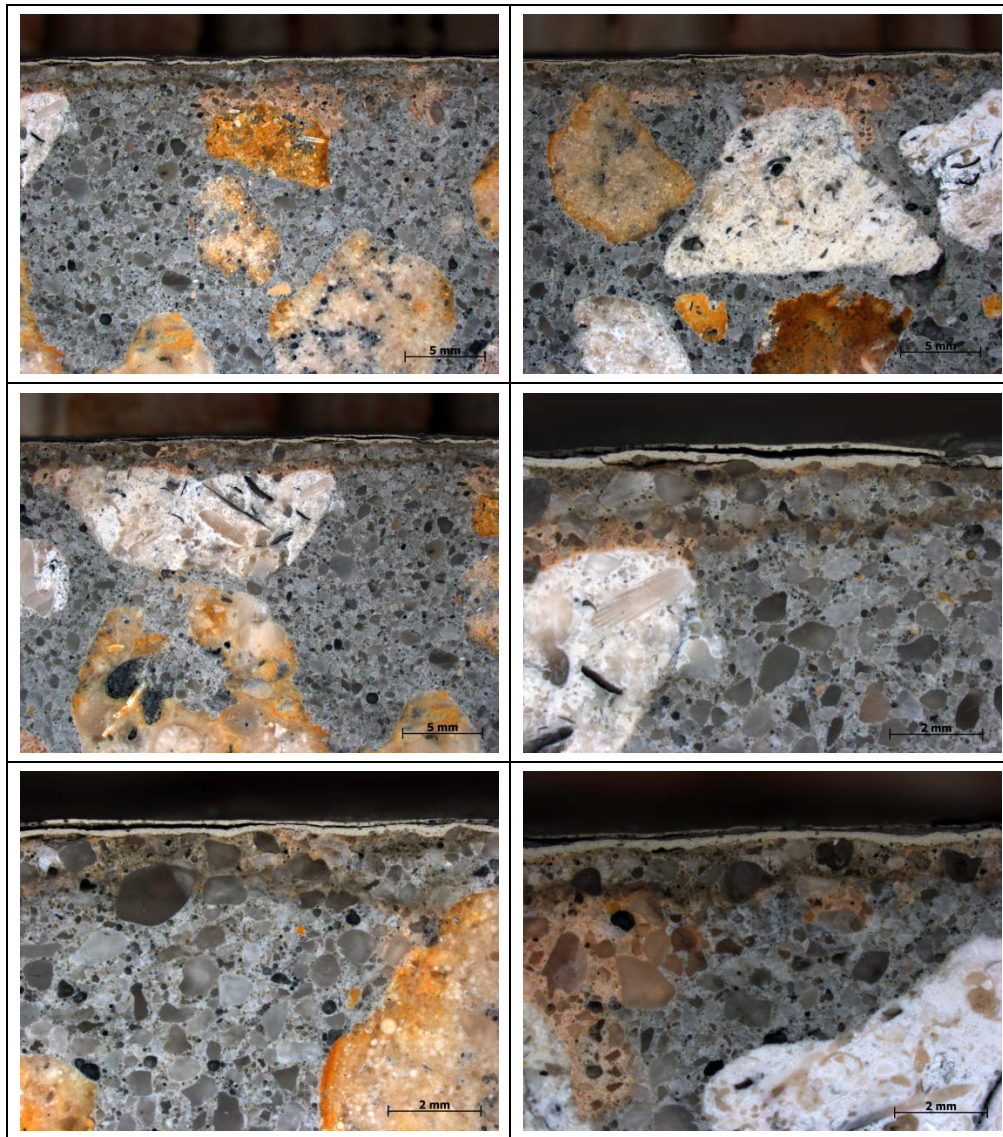
Figure A4. Supplemental photomicrographs of non-deteriorated concrete surface.

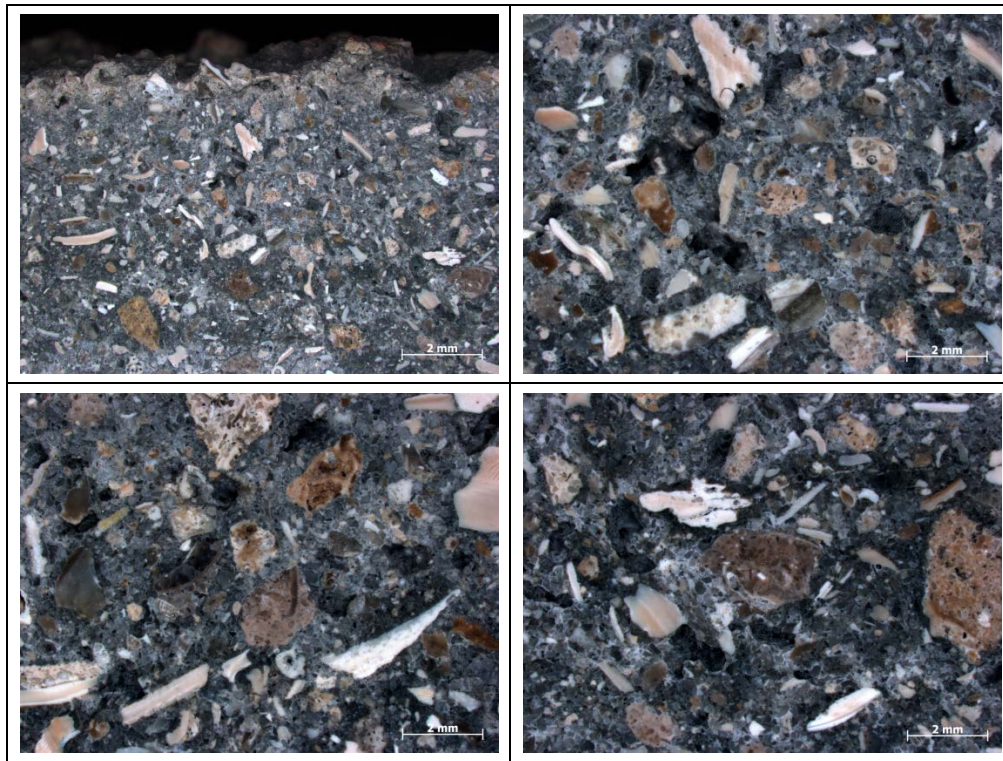
Figure A6. Supplemental photomicrographs of fractured sample of concrete, including deteriorated surface.

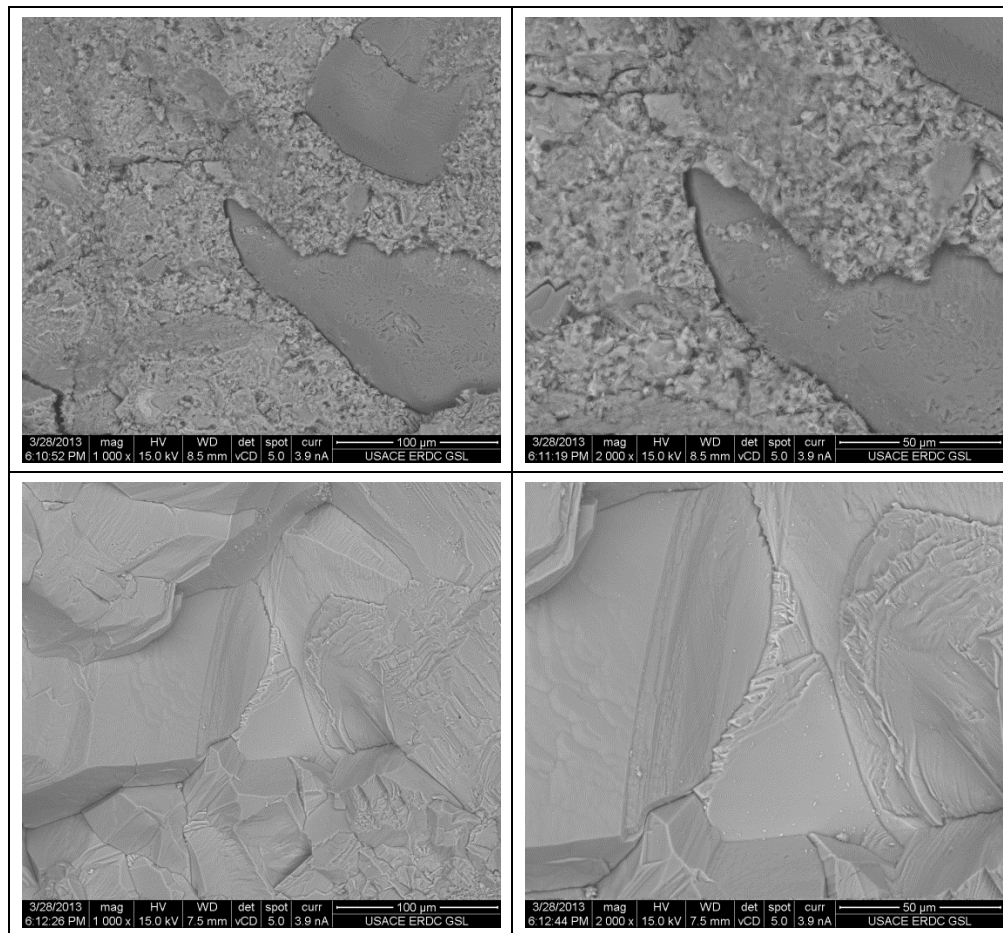
Figure B1. Supplemental SEM micrographs of inner non-deteriorated concrete fracture surface.
